## Upgrade of High Angle Conveyor for Cement

Industry: Cement | Service: Engineering

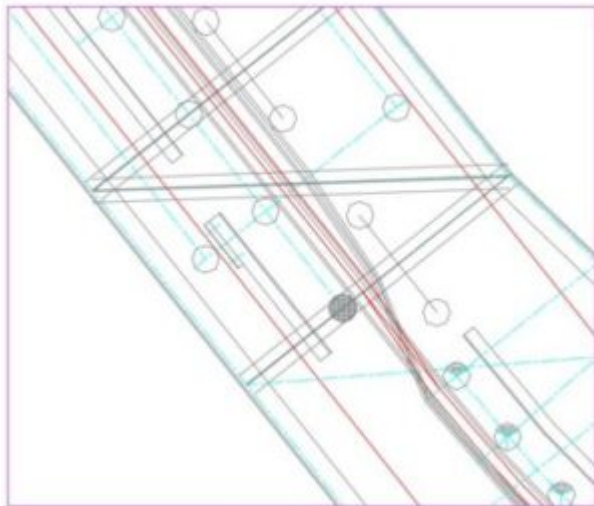
**Figure 1: Original CEMEX HAC, lower profile without inflection zone.**

To achieve proper performance of this HAC, DSI had to develop a proper inflection zone. This introduced a reverse curve just beyond the lower transition curve as shown below.

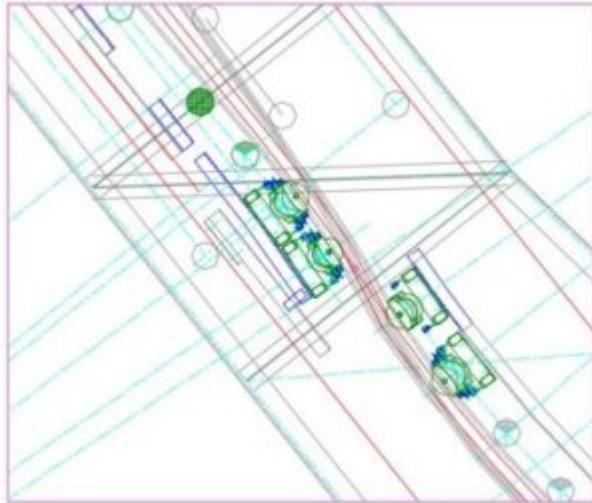
**Figure 2: New CEMEX GPS lower profile with proper inflection zone.**

The original lower curve must be extended beyond tangency with the straight HAC conveying angle. An additional reverse curve is introduced to bring the belt line back to the straight incline. Because this was a retrofit the belt line after the second short curve will be elevated about 4 inches above the original straight incline. Thus, this new belt line will be gradually worked back to the original straight inclined belt line, about halfway up the straight incline. New, additional steel support stringer and brackets will be required to achieve this.

Four FEI (fully equalized idlers) will be installed, two to either side of the inflection zone. These represent the latest in high angle conveying technology and were developed specifically for maintaining hugging pressure through the inflection zone, preventing any material slippage and spreading.
