# Wyodak Mine

## New Upper Support at HAC

On the night of the 28th of June 2013, a large storm blew through the town of Gillette, Wyoming. This storm, with reported wind gusts above 120 mph, damaged the upper support of the High Angle Conveyor, R-1, at the Wyodak Mine.

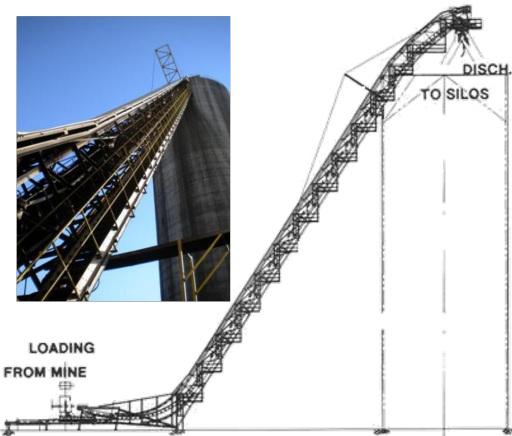
The high angle conveyor at Wyodak delivers coal, at a 57-degree incline angle, up to the center of a 5000-ton silo where it can discharge directly to that silo or, by actuation of a flop gate, can divert the coal flow to an adjacent 5000-ton silo. The structural system has only two major support points; a lower fixed hinge support at grade and an upper hinge-hinge frame, on the silo wall. The upper hinge-hinge frame allows expansion while offering a vertical support reaction. The truss support system consists of two major truss sections, the first from grade to the silo wall, and a second which cantilevers from the silo wall to over the middle of the silo. There is no support at the silo center. Rather, a steel bent mast with cable stays carries the cantilevered truss and all of its equipment in suspension from the silo wall. The back stays transfer the cantilever moment, in tension, back to the main truss that runs from grade to the silo wall. Figure 1 depicts the HAC profile, the structural system and summarizes the operating parameters.

HAC Sandwich Conveyor at Wyodak Resources

| Material | - Coal |
| -Density | - 0.88 t/cu-m (55 PCF) |
| - Size | - 51 mm (2") minus |
| Conveying Rate | - 1949 t/h (2150 STPH) |
| Conveying Angle | - 57 degrees |
| Belt Width | - 1829 mm (72") |

**Figure 1: The high angle conveyor (HAC) at Wyodak features a highly efficient structural system that cantilevers from an upper support on the silo wall to suspension over the center of the silo.**

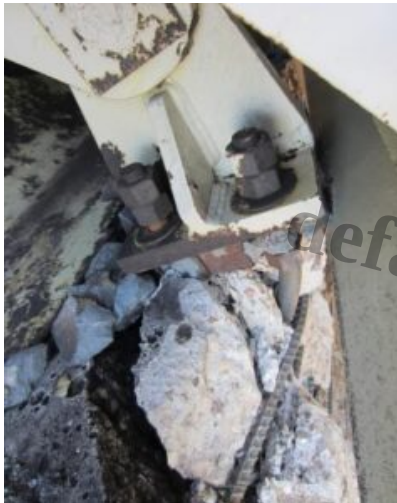
**Figure 2: Failed concrete under hinge pedestal.**

work and transfer conveyor. The overhead cable stays that previously cantilevered the upper structure were now slack and carried no load. Inspection revealed very little physical damage to the High Angle Conveyor structure. The failure was contained within the area surrounding the upper hinge-hinge support frame. More specifically, the failure was at the top of the silo wall, at the concrete directly under the lower hinge pedestals. Dos Santos concluded that the wind from the storm pushed the conveyor toward the silo. This forced the upper hinges (of the hinge-hinge frame) towards the silo center forcing some rotation about the lower hinges. The forward rotation meant that the upper reaction load now applied a horizontal outward load in addition to the vertical load for which the system was designed. The combination subsequently blew out the lower concrete support. Figure 2 shows the location and the extent of the damage.

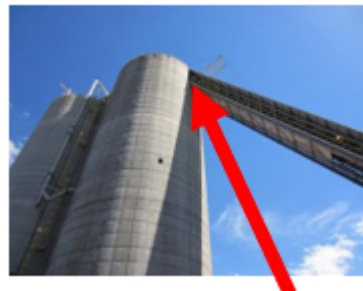
Upon Dos Santos's arrival at the site, the conveyor was thoroughly inspected. With the upper wall support collapsed, the lower truss came to rest (leaning) on the steel framing that supported the receiving chute.

end came to rest on the steel framing that supported the receiving chute.

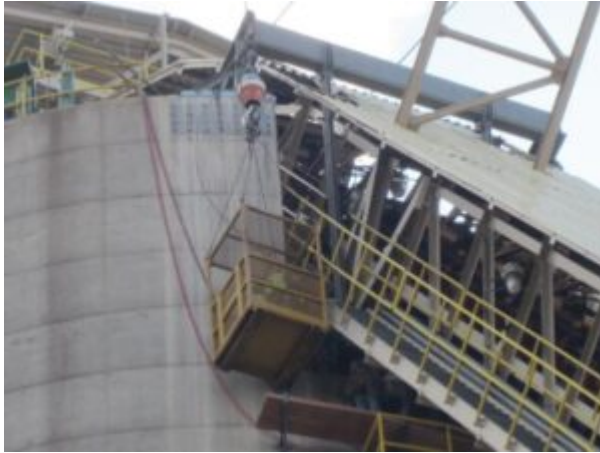
**Figure 3: With the new upper support system complete, the HAC is ready to resume productive operation.**

As a solution, Dos Santos decided to build a new hinge-hinge type support. However, this time larger, doubly hinged bars would hang from a cross beam that would span the width of the conveyor truss and access, above the conveyor, on the silo wall. Figure 3 shows the new overhead crossbeam and hangers. This solution allowed easy access to the new support system and facilitated securing the load temporarily from the new upper crossbeam, while working safely at the former structure, removing the old hinge-hinge frame and welding two stages of temporary cross beams and a permanent cross beam under the truss structure. The first temporary crossbeam, a thick rectangular bar across, was to lift the HAC upper support point, only slightly, enough to relieve the load on the old support. This was to allow its safe removal and to allow the installation of the lower lifting beam and the permanent crossbeam that would connect with the hanger bars at the same location as previously. Because the new hangers are longer, the design more easily accommodates the longitudinal displacement of the conveyor.

In order to place the conveyor back in its original location, the contractor utilized a “jacking beam” atop the permanent upper supporting beam, with chain falls attached to a temporary lifting beam, installed full length underneath the conveyor structure, adjacent to the lower permanent support beam. With two 55-ton jacks, the conveyor was slowly lifted back into place. Once lifted, the new hanger bars and pins were installed. The fixed length of the bars confirmed that the conveyor had been placed in its final design position. Finally, a lateral hinge-hinge bar was installed, connecting the lower hanger beam to the silo wall. This lateral hinge-hinge support is designed to resist the side loads on the conveyor system while allowing free expansion of the structure.
